FINAL REPORT MARSHALL SPACE FLIGHT CENTER CONTRACT # H-08082D& #H-11210D

"ADVANCED FLOW-POLISHING AND SURFACE METROLOGY OF THE SO56 X-RAY TELESCOPE"

BAKER CONSULTING 3/2/1992

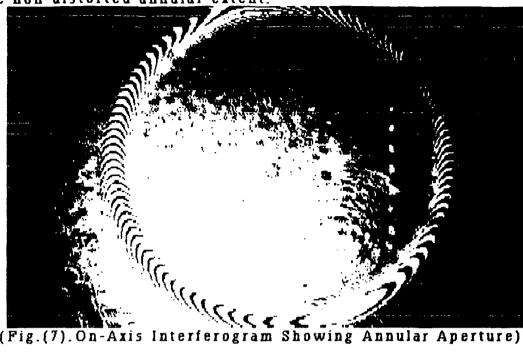
(Fig. (7). On-Axis Interferogram Showing Annular Aperture)

In figure (7) the full annulus is shown, the fringe detail is not nearly as pronounced as in figure 4. There is still strong spherical and the presence of astigmatism indicated in the non-symmetry of the full fringe pattern, the astigmatism is also irregular (skewed axis of astigmatism), making the use of any corrector negligible.

It is extremely difficult to correct for this out-of-roundness condition, the only available option is to attempt to correct the spherical as much as possible and not to exacerbate the existing roundness error.

Due to this initial condition of high axial spherical and roundness error an initial contact technique was utilized to smooth and correct the wavefront error that existed in the surface. A combination of jet polish and close contact polish with a strong mechanical vibratory motion was applied in the first stages. Due to the confidential nature of this technique this will not be described in great detail in this report, only the data will be discussed.

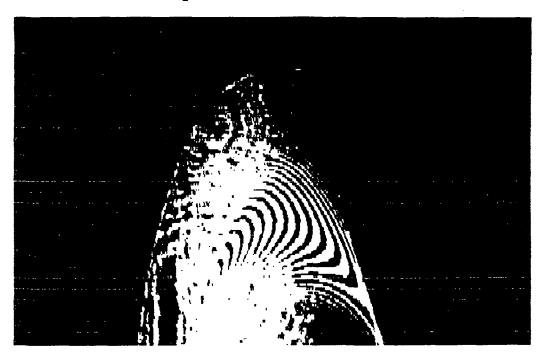
(Fig.(12).Sampled Area Using Lateral Shear.)

This shearing technique allowed a rapid assessment of the local area along the axis of the wavefront changes. This lateral shear does not test both vertical and horizontal simultaneously, however it does test the axial contour efficiently and is relatively vibration free.
